REQUIREMENTS TO FACILITATE INSTALLATION OF:

- **TREVIRA FABRIC WALL CLADDING**
- **WALL PROTECTION NETTING**

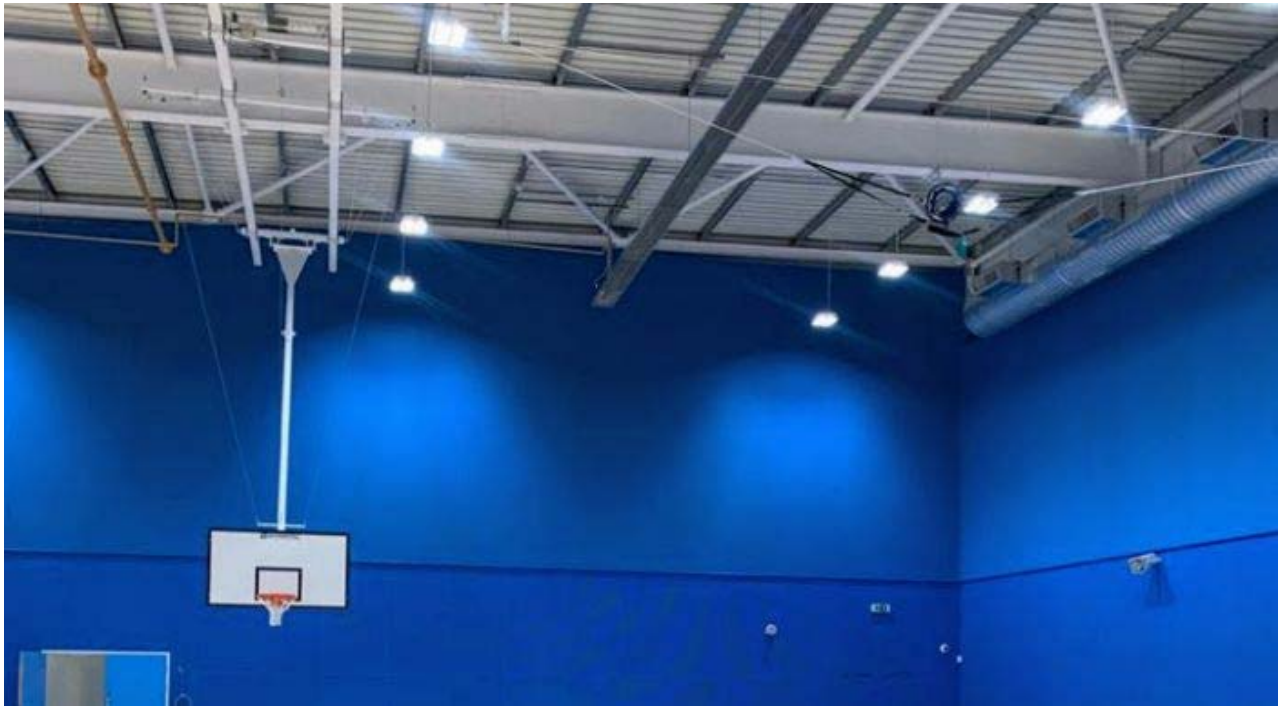
Continental Sports' fabric wall cladding system provides the ideal solution to covering the inside face of metal wall cladding. It offers the following benefits:

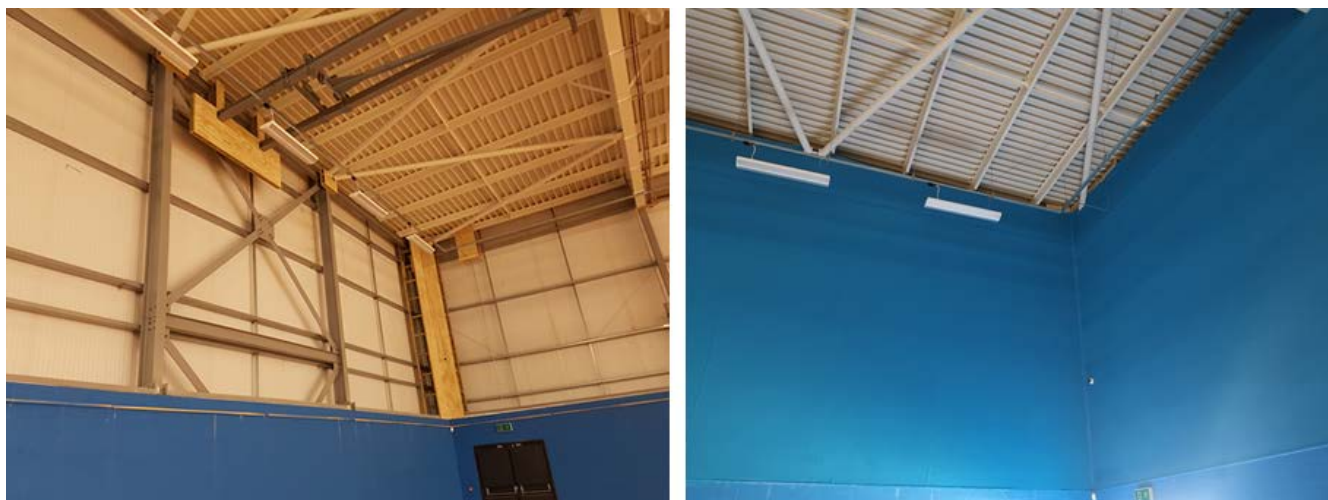
The image below on the left shows a typical internal sports hall wall with impact boarding at low level and cladding / columns / cross-bracing and the internal face of wall cladding visible. The image on the right shows the same wall area after the installation of Trevira fabric wall cladding.

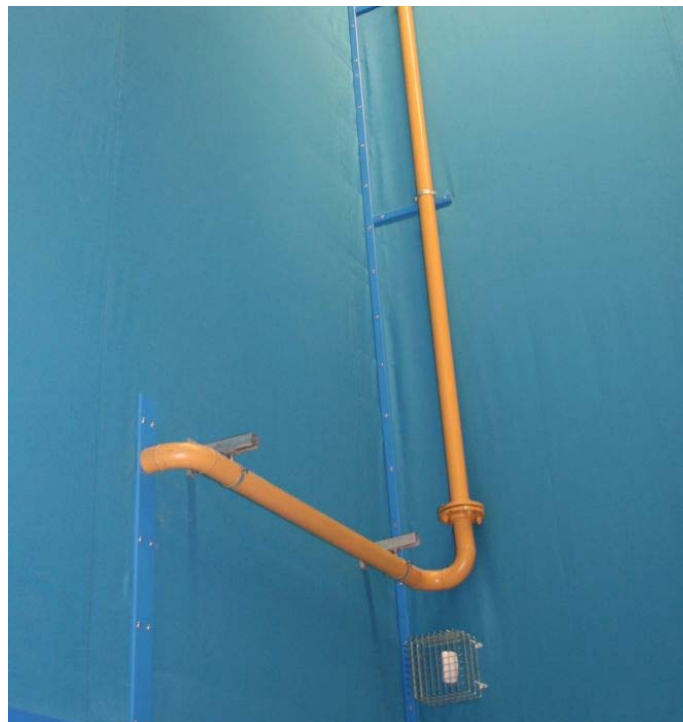
The image below shows the impact of a protrusion that is distant from the edge of the fabric. As we must cut vertically from the edge to the protrusion and cover that cut with a timber lath, the more protrusions and the further they are from the edge, the more timber laths are necessary and the longer they must be which all impacts the visual finish of the product.

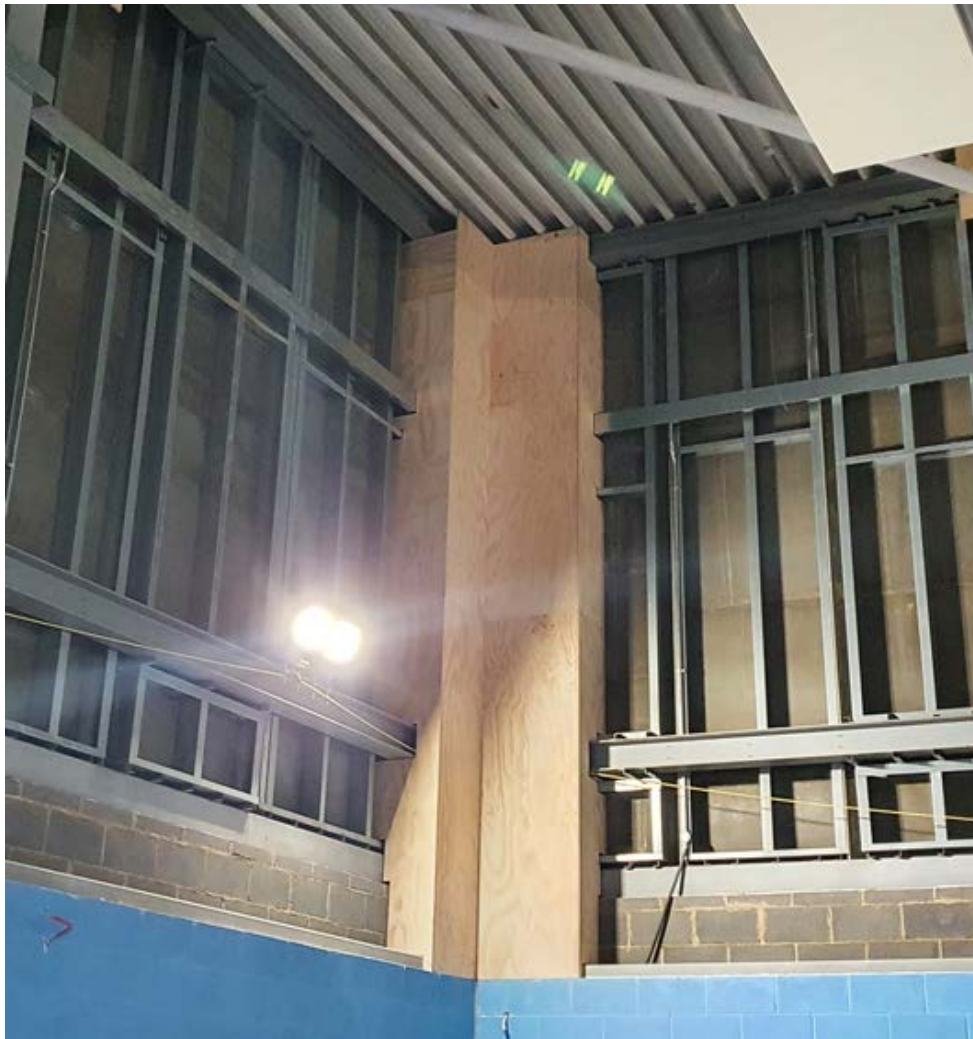
- 1) **VERTICAL CORNER TIMBERS** - Vertical timbers in each corner of the room from the top to the bottom of the edge of the fabric. These can be rough sawn timber, or plywood (any timber that we can staple the fabric to and screw fix a timber lath to - so if plywood we require at least 12mm thick) and must protrude at least 100mm from the edge of the fabric down each wall. If the wall covering is to be netting rather than Trevira, these should be painted (by others) in a colour to match the cladding or netting as they will remain visible. If the covering is Trevira the timbers will be hidden so do not require finishing.

IMPORTANT NOTE: All the types of timbers that we require to be installed must finish in line with the low level blockwork / impact boards and the line of the fabric - i.e. the timbers must not be recessed back from the vertical plane of the fabric.

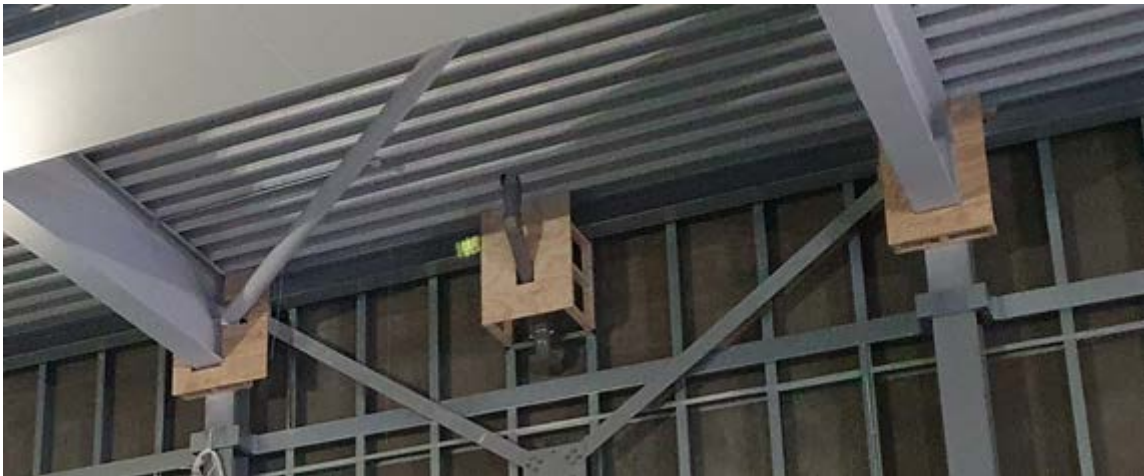
The image below shows timbers around rafters that are protruding through the top edge of the Trevira. PLEASE NOTE: We can either finish the top edge horizontally under the lowest point of any roof beam, or we can cut the fabric around roof beams to provide a castellated effect. The latter is aesthetically more attractive but more costly due to the additional time required for installation. The text in our quotation describes which method we have quoted for so please ensure it is the version you require, or ask for an alternative cost.

The image also shows a drainage pipe protrusion with timber surrounding the protrusion and from the protrusion to the top edge of the fabric.

- 2) **PROTRUSION SURROUND TIMBERS** - Timber around any protrusion through the fabric. This should be at least 40mm around the protrusion and if plywood at least 12mm thick. THIS IS NOT REQUIRED IF THE CLADDING IS NETTING RATHER THAN TREVIRA

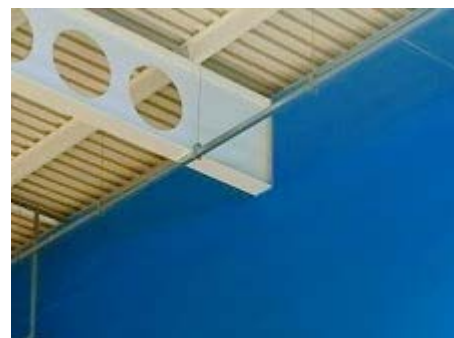
The image to the right shows Trevira with the top edge at maximum height with the fabric cut around each rafter:

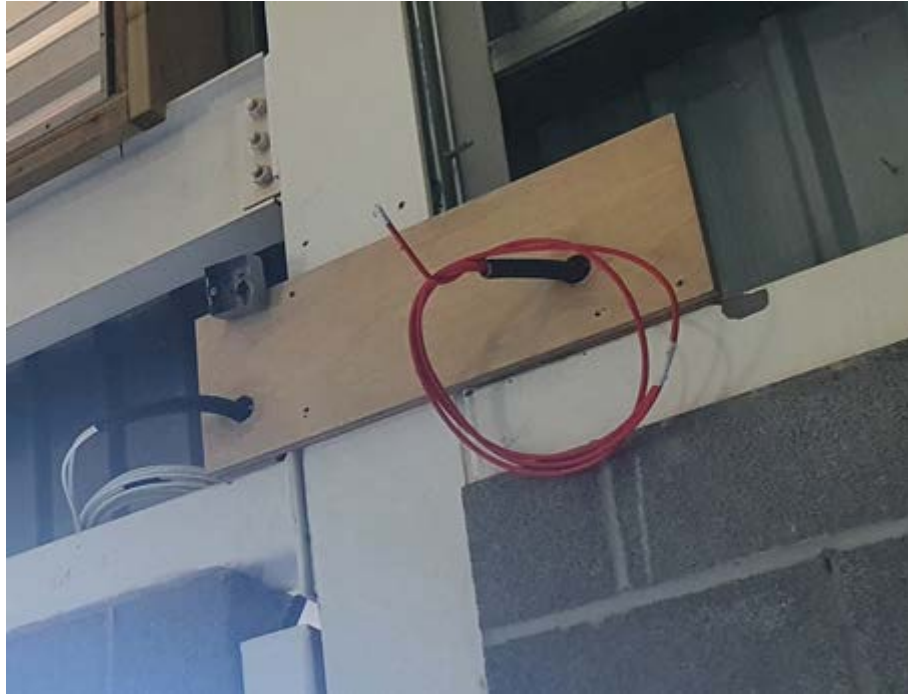
The image below shows a protrusion (for data / alarm / wifi points) that is at the bottom edge of the fabric so does not need any additional vertical cut timbers.

- 3) **VERTICAL CUT TIMBERS** - Timber at least 40mm wide from any protrusion vertically from the protrusion to the closest of the top or bottom edge of the Trevira. THIS IS NOT REQUIRED IF THE CLADDING IS NETTING RATHER THAN TREVIRA

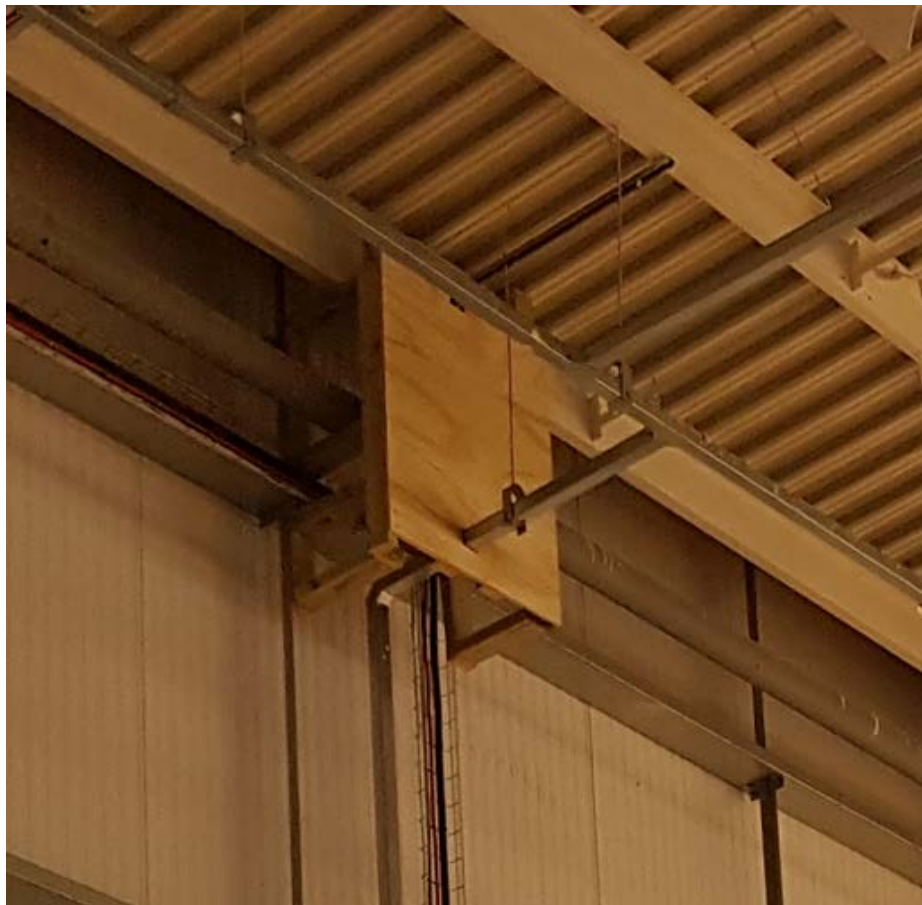
The image below shows protrusion surround timbers for a lighting power conduit and vertical cut timbers from the protrusion to the closest top or bottom edge of the fabric - in this case the top edge.

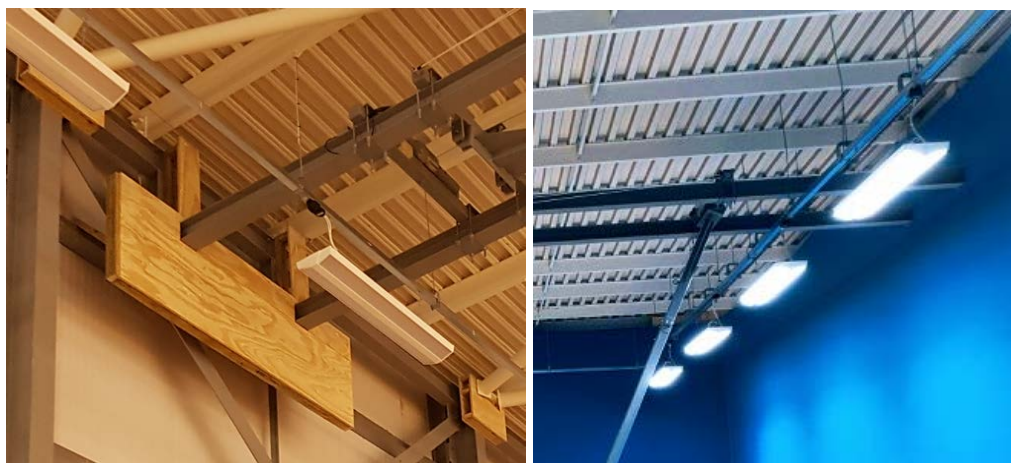
The image below shows protrusion surround timbers around secondary support steelwork for ceiling mounted basketball goals and vertical cut timbers from that protrusion to the top edge of the fabric, along with an image showing the Trevira around those steels following installation.

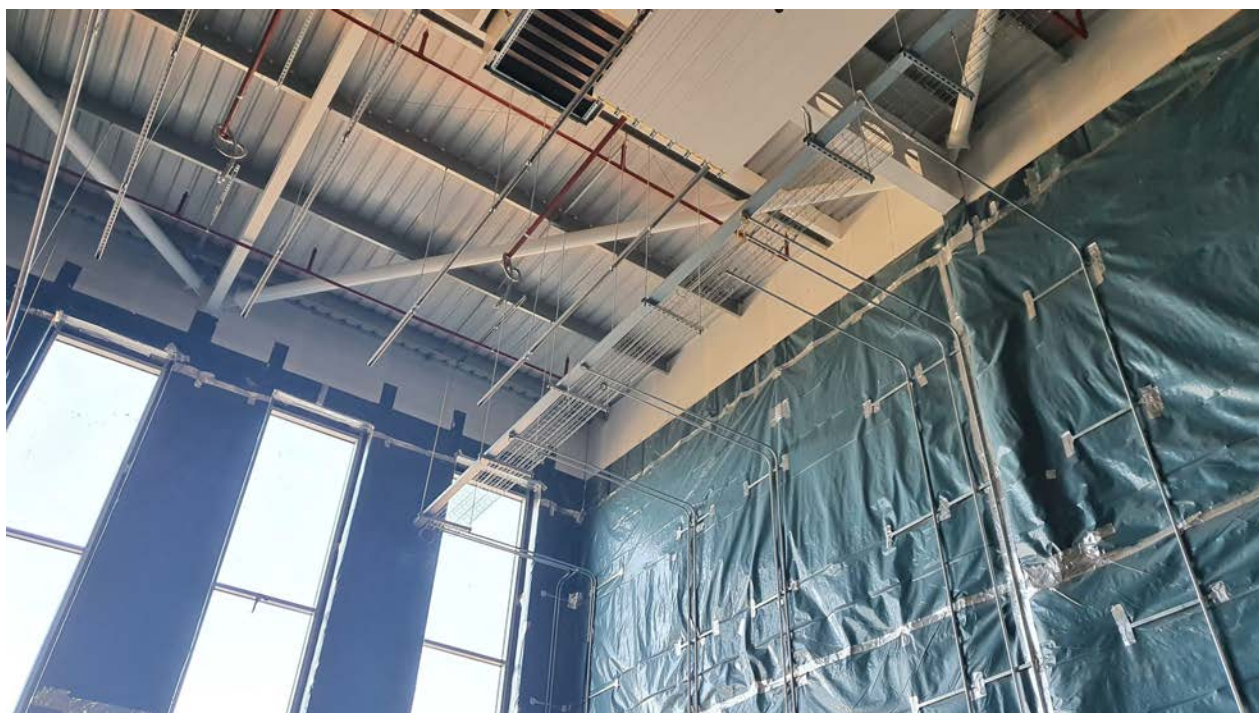
- 1) The image below shows multiple protrusions of electrical conduit that would need to pass through the fabric. Each protrusion requires a cut in the fabric and timber patressing around each protrusion. The number of protrusions mean the fabric is virtually guaranteed to pucker and ripple in that area. The conduit also prevents access equipment being able to access the soffit where the bracketry and cables are due to be fixed and prevent operatives being able to attach the fabric in that area.

The images below show a site where consideration had not been given in advance to the installation of Trevira fabric wall cladding:

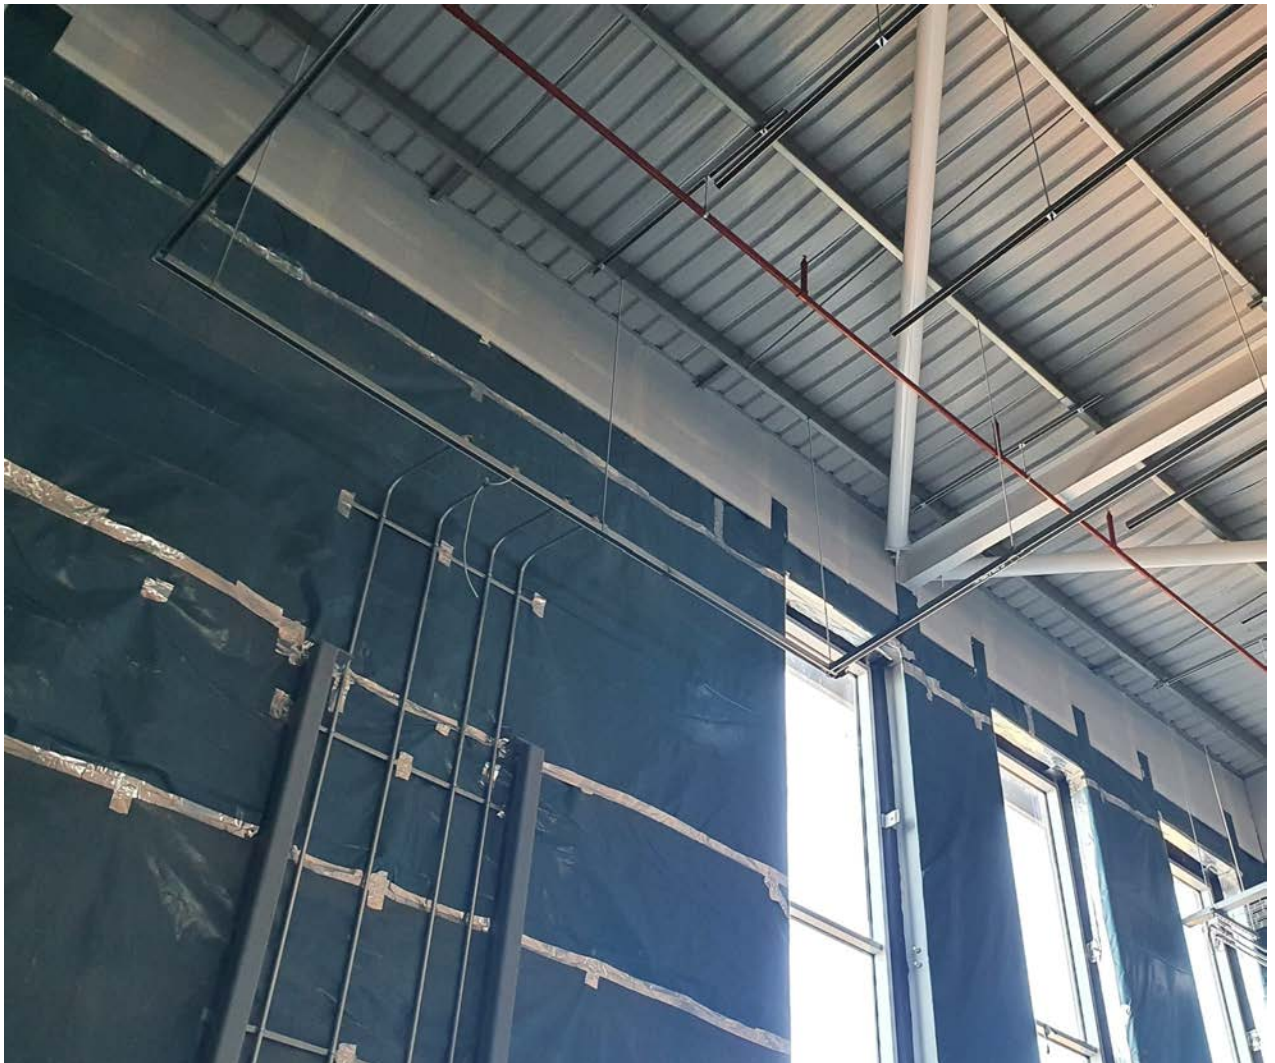
- 2) The U-shaped lighting trunking / conduit shown below prevents operatives from using a MEWP or similar access equipment from reaching the soffit and roof steelwork onto which brackets must be fixed. The multiple protrusions of conduit going from the wall to the trunking mean that there will be puckering and rippling in the finished fabric.
